# Troubleshoot Phone Firmware File Installation Failures on the CUCM

Document ID: 118926

Contributed by Krishna Pradeep Venugopalan, Cisco TAC Engineer.  
Apr 21, 2015

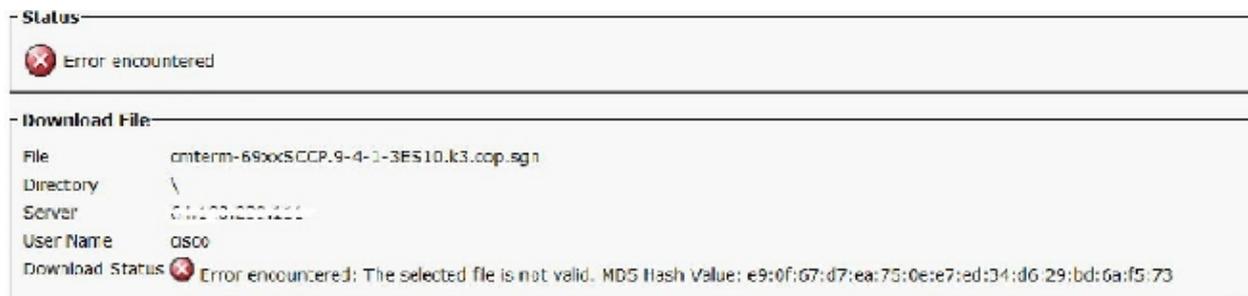
When you attempt to install phone firmware files with a *k3.cop.sgn* (signed file) extension on the CUCM server, you encounter a file installation failure. The CUCM produces an output in order to indicate that the file is invalid, which appears similar to this:

In order for the CUCM to support these firmware files, which are signed with k3 keys, it must already have the *ciscocm.version3-keys.cop.sgn* file installed on the CUCM server. If the CUCM server does not have this file installed, visit the Cisco Download Software page in order to obtain the most recent RSAv3 key Cisco

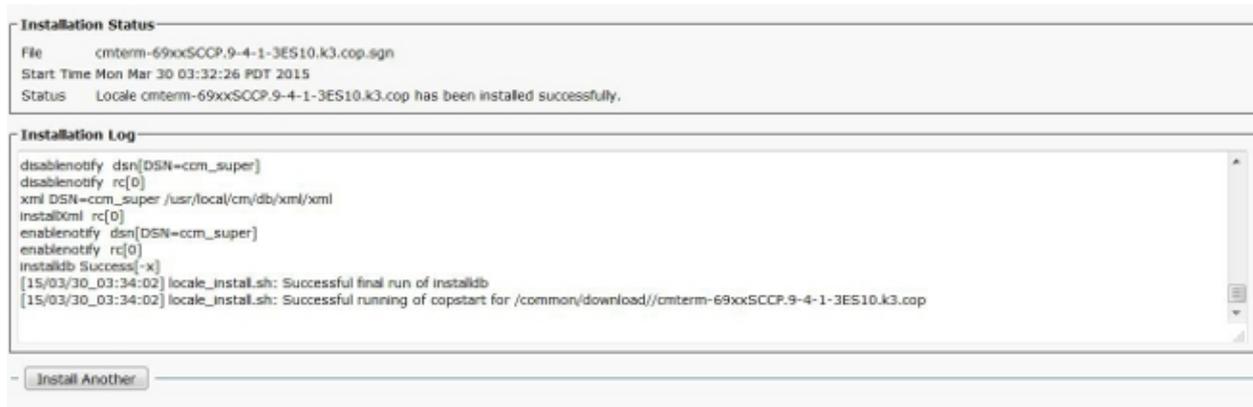
Once you have obtained and installed the *ciscocm.version3–keys.cop.sgn* file successfully on the CUCM server, the *.k3.cop.sgn* phone firmware file installation should proceed successfully:
