ICM Drops Translation Route to IP IVR Calls

Document ID: 50582

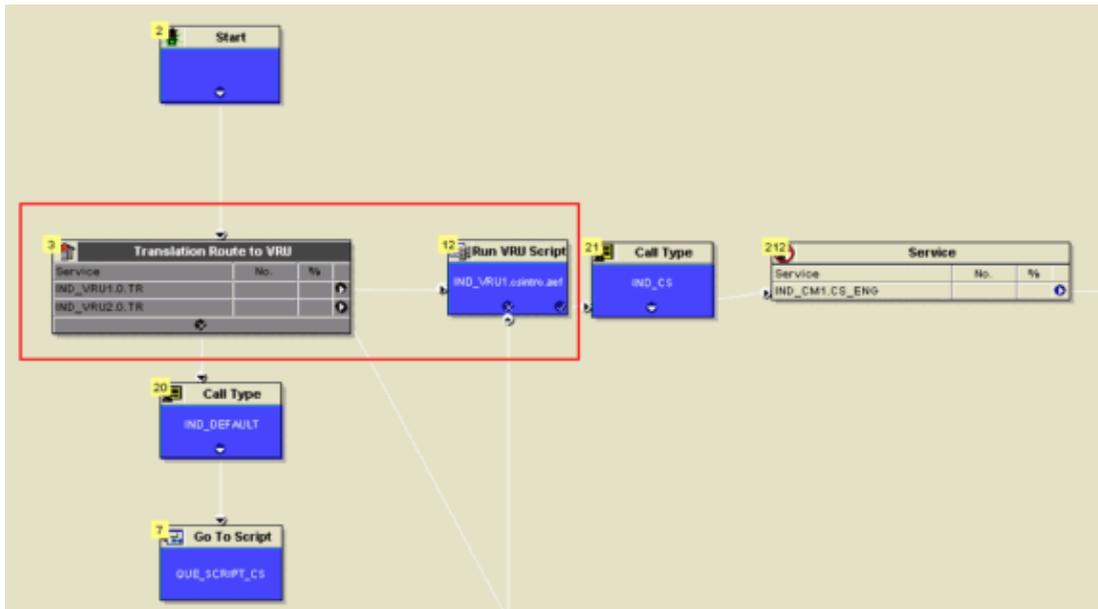
The ICM route point is associated with an ICM script which does a Translation Route to a VRU node to trigger a script on the IP IVR, as shown in below. This Translation Route VRU node fails.

When testing this specific ICM script through CallTracer, it completes correctly. However, when the incoming call hits the route point in the production environment, it fails with the following sequence:

1. Experiencing a short bit of silence.
2. A fast busy.

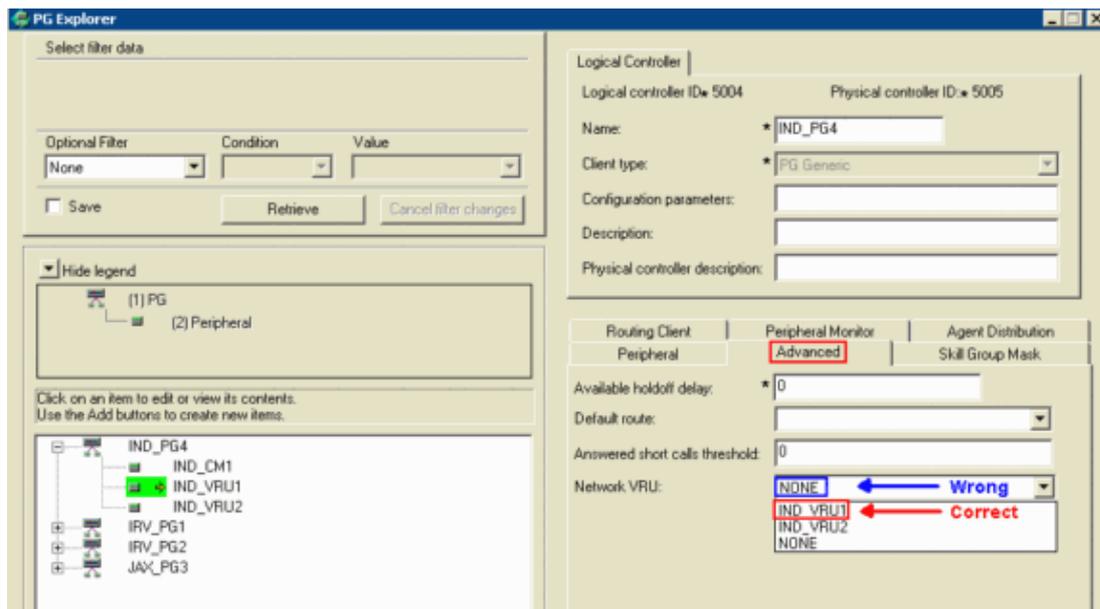
This is a configuration issue. View the rtr log file on the Router using the Dumplog utility, the following message appears:

```
15:20:51 ra-rtr Trace: TranRouteToVRU failed. Unable to map route 5009 to a network VRU
```

Verify the specific route, it is associated with a specific IP IVR. Check the configuration in PG Explorer, the **Network VRU** name is set to **NONE** instead of the name of this specific IP IVR under **Advanced**, as shown below. Select the right Network VRU name resolves this issue.
