Understanding Jitter in Packet Voice Networks (Cisco IOS Platforms)

Document ID: 18902

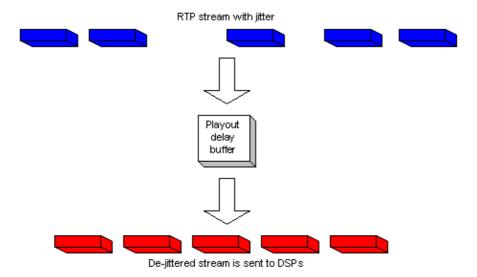
When a router receives a Real-Time Protocol (RTP) audio stream for Voice over IP (VoIP), it must compensate for the jitter that is encountered. The mechanism that handles this function is the playout delay buffer. The playout delay buffer must buffer these packets and then play them out in a steady stream to the digital signal processors (DSPs) to be converted back to an analog audio stream. The playout delay buffer is also sometimes referred to as the de-jitter buffer.

This diagram illustrates how jitter is handled.

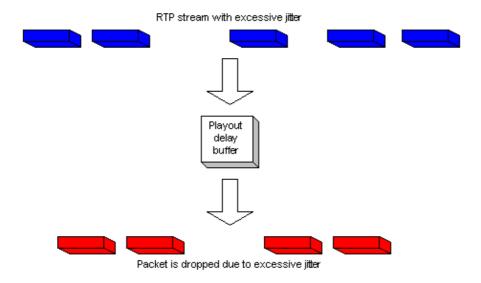
If the jitter is so large that it causes packets to be received out of the range of this buffer, the out-of-range packets are discarded and dropouts are heard in the audio. For losses as small as one packet, the DSP interpolates what it thinks the audio should be and no problem is audible. When jitter exceeds what the DSP can do to make up for the missing packets, audio problems are heard.

This diagram illustrates how excessive jitter is handled.
