Troubleshooting No Ringback Tone on ISDN–VoIP (H.323) Calls

Document ID: 22983

This document addresses call progress in–band related issues when interworking ISDN and H.323 signaling between VoIP and Public Switched Telephone Network (PSTN) networks. Challenges arise when Cisco VoIP router/gateways exchange signaling capabilities with the Telco switch.

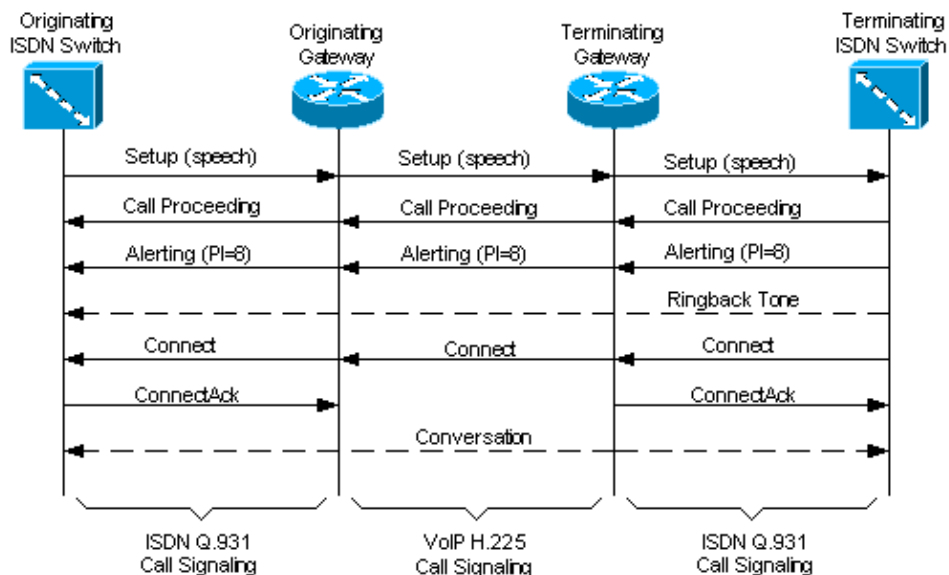
Call Setup Q.931-H.225 Messages

Note: H.225 is a protocol specified by H.323 for call signaling and call setup. H.225 specifies the use and support of Q.931. Refer to the H.323 Tutorial [\[4\]](#) for more information on H.323.
